BRASTER S.A.

Thermography test interpretation dated 06.11.2021 ordered on 06.11.2021

Examination details

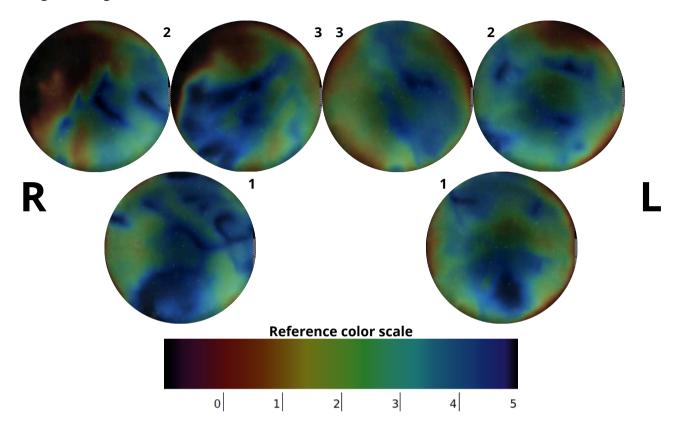
Original images (matrix no. 2)

The interpretation of the examination did not detect any thermal irregularities. Further breast control as prescribed by your physician is recommended.
