BRASTER S.A.

Thermography test interpretation dated 05.11.2021 ordered on 05.11.2021

Examination details

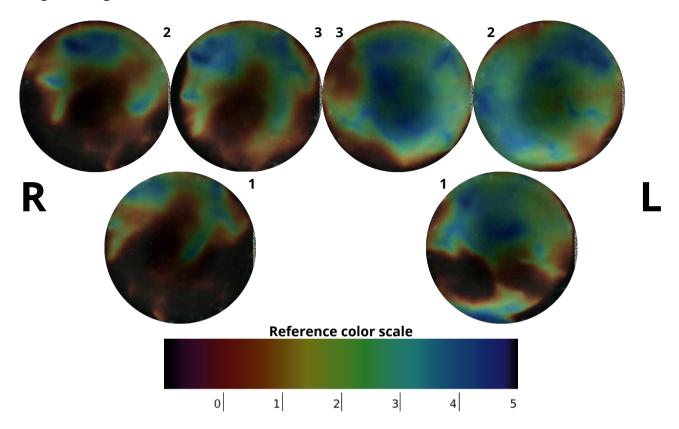
Original images (matrix no. 3)

The interpretation of the examination did not detect any thermal irregularities. Further breast control as prescribed by your physician is recommended.

Value:	Norm:
Thermal asymmetry parameter:	0,00*	from -2 to 2
Structure asymmetry parameter:	-0,93*	from -2 to 2
Main thermal structure area ratio:	3,04*	from -4 to 4
Main difference ratio of surface thermal structures areas:	25 560,50*	from -20,000 to 20,000

^{*} Coefficients were considered to be insignificant on the basis of vision analysis
